DEPARTMENT OF TRANSPORTATION**DIVISION OF ENGINEERING SERVICES**

Quality Assurance and Source Inspection

Contract #: 04-0120F4Cty: SF/ALA Rte: 80 PM: 13.2/13.9File #: 69.15**SOURCE INSPECTION REPORT****Resident Engineer:**Pursell, Gary**Address:** 333 Burma Road**City:** Oakland, CA 94607**Report No:** SIR-001856**Date Inspected:** 26-Feb-2010**Project Name:** SAS Superstructure**OSM Arrival Time:** 700**Prime Contractor:** American Bridge/Fluor Enterprises, a JV**OSM Departure Time:** 1900**Contractor:** Zhenhua Port Machinery Company, Ltd (ZPMC), Changxing Island**Location:** Chang xing dao, Shanghai**Quality Control Contact:** Mr. Don Walton**Quality Control Present:** Yes No**Material transfer:** Yes No N/A**Sampled Items:** Yes No N/A**Stock Transfer:** Yes No N/A**OK to Cut:** Yes No N/A**Rebar Test Witness:** Yes No N/A**Delayed/Cancelled:** Yes No N/A**Other:** Coating Inspection**Bridge No:** 34-0006**Component:** See below**Bid Item:** 77, 78, 79**Lot No:** B #204**Summary of Items Observed:**

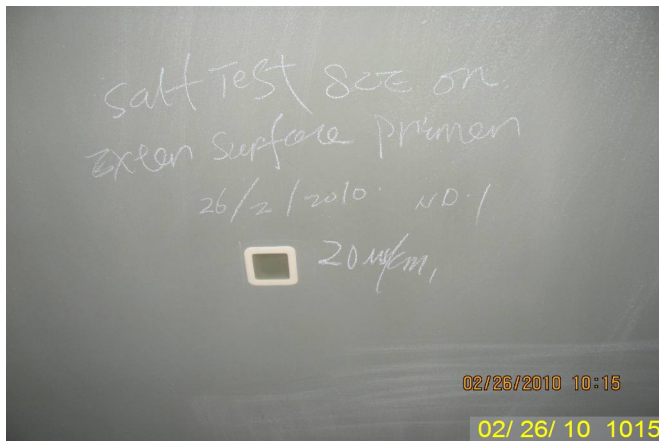
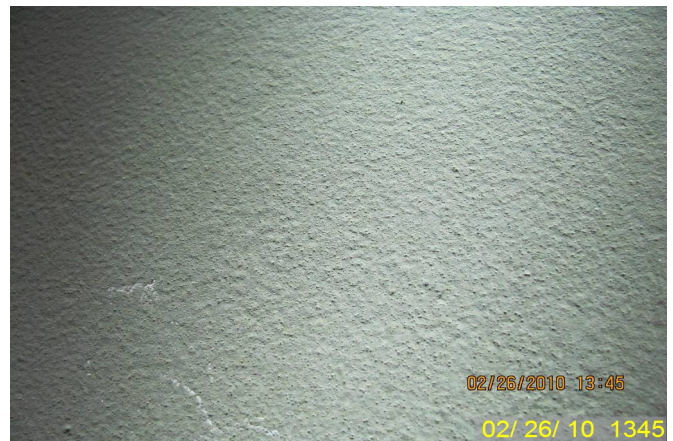
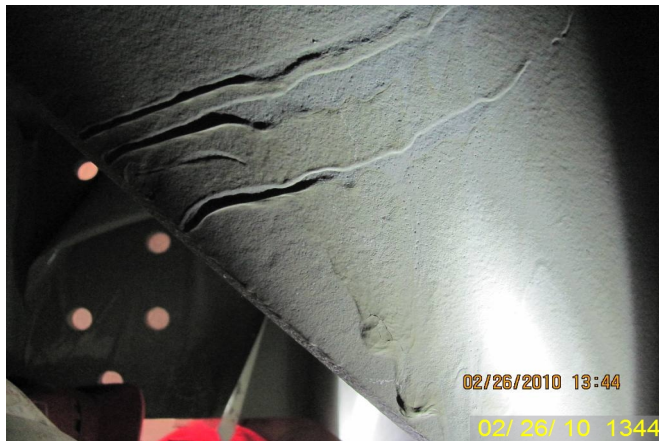
2. An inspection was requested on 6 sets of OBG Suspender bracket for the surface preparation Inspection for primer coat application, DFT Check and MEK Pencil hardness test vide inspection request no. 2757. The suspender brackets are SB 32E-2 nos, SB32W- 1 no., SB34W- 1 no., SB30E- 1 no., SB30W-1 no. The ambient conditions during the inspection found to be 4.8 deg. above dew point and the relative humidity found to be 69% inside the paint shop which is found to be within the parameters of contract documents. This Caltrans inspector observed, ABF inspectors Mr. Shi stone and Mr. Jiang huan, Mr. Wei and Mr. Turtle performing DFT check, and Low DFT, sagging, Mud crack and pin holes(Photo of sagging and pinholes attached) observed in Suspender

bracket no. SB34W which was rejected by ABF Inspectors. International protective coatings technical service representative Mr. Li peng was found present during the course of this inspection process.
